**COATINGS FOR LIGHTNING PROTECTION OF  
STRUCTURAL REINFORCED PLASTICS**

**TECHNICAL REPORT AFML TR-70-303 PART II**

Air Force Materials Laboratory  
Nonmetallic Materials Division  
Air Force System Command  
Wright-Patterson Air Force Base, Ohio

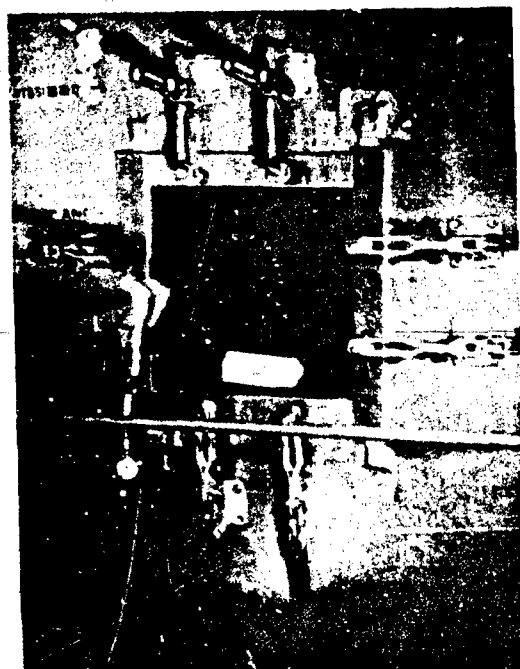
Figure 20.  
Pickup Loop Shown From Within Faraday Cage

The loop configuration and its orientation with respect to the discharge probe located the axis of the individual turns orthogonal to the induced current flow (Fig. 19). The configuration also made any effects due to nonsymmetry of the current flow from the arc attachment point to ground negligible. A photo of the loop from within the Faraday cage is shown in Figure 20.
